# COIL TUBING RECOVERY

## Safe and Cost Efficient

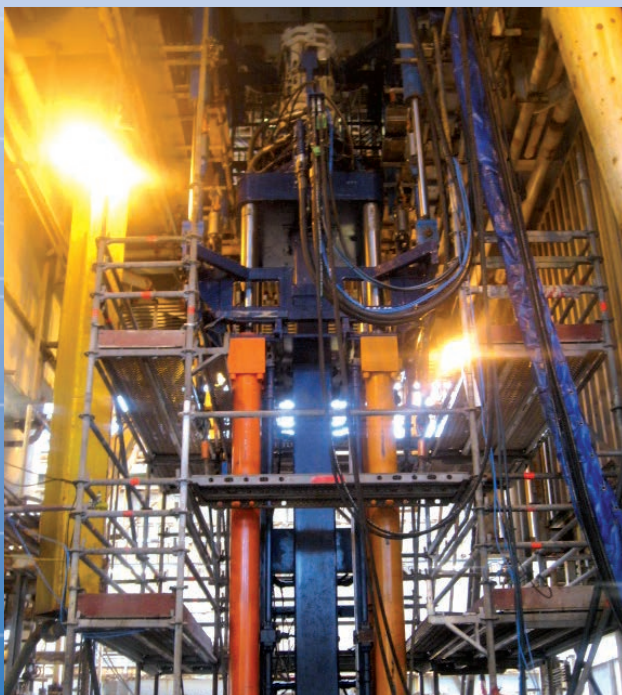
During the first string installation a runaway occurred which resulted in the shear seals being closed on the coil to secure the Well.

The objective was two parts: Firstly, to regain the use of the tree by clearing the coil across the tree. Secondly, to clear the coil to below the safety valve and regain use of the safety valve.

- HWU was utilised due to the availability of competent personnel and was cost effective in comparison to re-starting the rig.
- The tree was to be cleared using a mechanical rotating external cutter.
- Tension was then to be applied to the coil and an e-line cutter deployed to below the safety valve.
- Cut was to be made and coil recovered to surface.
